# AC Service & Duct Cleaning

Ref. ARC-SR-0000 · Completed

| VISIT DATE<br>DD Month YYYY | TECHNICIAN<br>Arcta AC Technician | UNITS SERVICED<br>3 ducted split units |

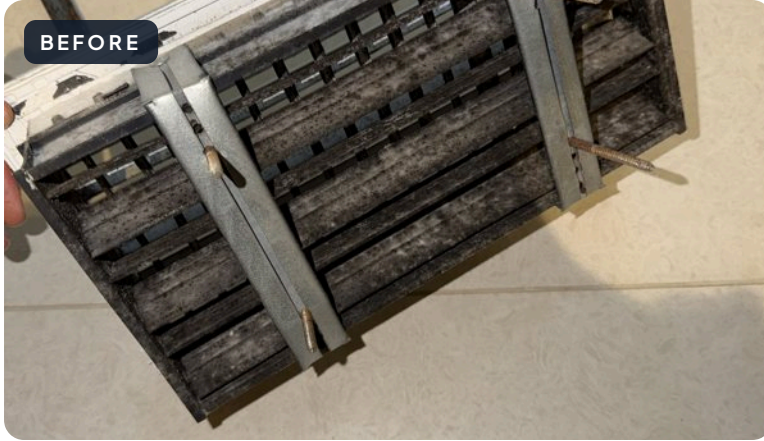
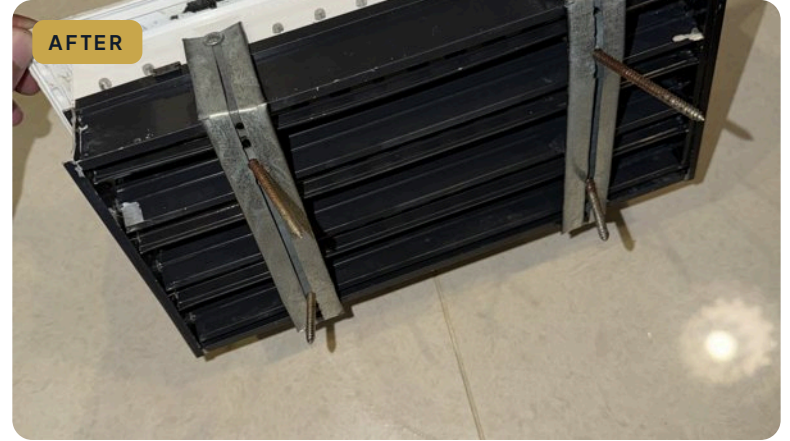
Living room supply grille

| UNIT | FOUND | BEFORE | AFTER |
|---|---|---|---|
| Living room | Filters clogged with dust and lint. Mould on supply grille louvres. Dust build-up inside supply duct. | Poor | Good |

- Filters removed, washed, dried and refitted on all 3 units
- Supply grilles removed, deep cleaned and refitted
- Living room supply duct cleaned through to the grille
- Drain trays cleaned and drain lines flushed
- Cooling and airflow checked on all units after service
- Work area covered and cleaned before leaving
